BUILDING CODES

Ten Common Code Violations Pay close attention to these to avoid failing inspections

BY CHARLES WARDELL

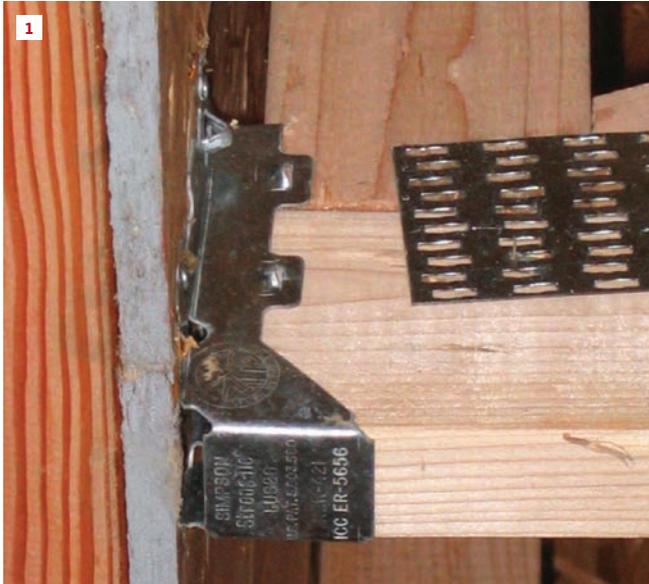
The gap at the end of the floor truss is a tell-tale sign of a framing violation. Any truss or joist must have full bearing on the hanger seat. This hanger may be undersized, as well, for the size floor truss it supports.

One of the biggest problems Mathewson sees is gaps at the ends of joists or trusses supported by hangers (1). It doesn’t take much: Gaps can be caused by a girder truss that’s slightly crooked or out of plumb, making the time required to use a string line and level well spent.

Manufacturers of structural hangers usually specify a maximum gap of 1/8 inch between the end of the joist and the girder. Anything bigger will put moment arm on the hanger and drastically reduce its load capacity. When hangers are double-shear nailed (toenailed), large gaps leave the nails completely missing the carried member. “People get upset over this because they think I’m being punitive,” he said. “It’s not me, it’s the manufacturer’s load requirements.”

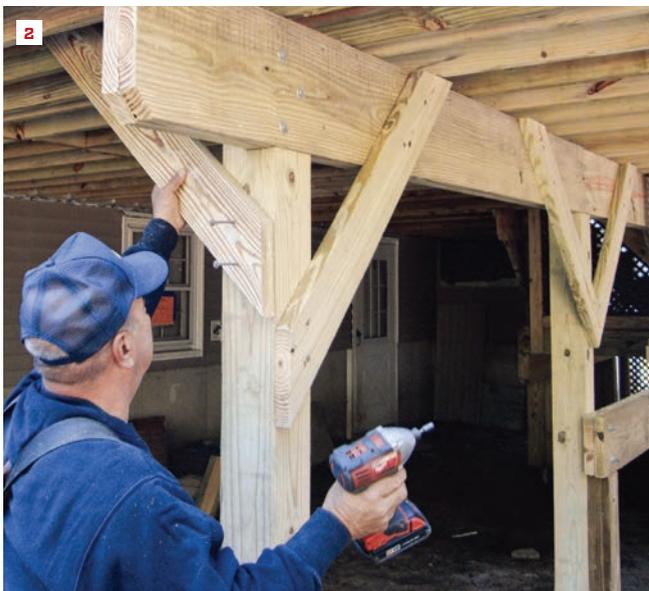
Racking resistance is a structural key to a deck that will resist failure over time. This photo shows an effective way to brace deck posts. Running the diagonals in both directions provides much-needed racking resistance.

He also finds builders falling down on deck shear-bracing requirements. Typically, diagonal post bracing is required (2). To further resist racking, builders can also use flat-framed 2-bys run diagonally on the underside of the joists. “Racking is a source of failure over time. If the deck isn’t properly braced, fasteners will work loose,” Byle said. He added that it doesn’t take much: “Something as simple as kids running around and banging into rails can put stress on the fasteners.”
